**CASE STUDY - Durham County Council Byerleyhouse Bridges Repairs**

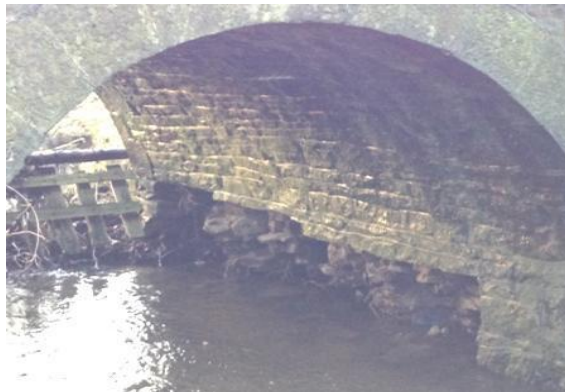
**Before:**

Following Post Flood Inspections in December 2015, Durham County Council appointed Bridgeway (Framework Supplier) to repair the scour to abutment wall. The council requested new foundations (600mm wide x 300mm deep) to be cast in-situ to the side where the repair was required, and mirrored on opposite abutment. In addition they requested a 150mm invert with 400mm deep toe to the upstream and downstream sides.

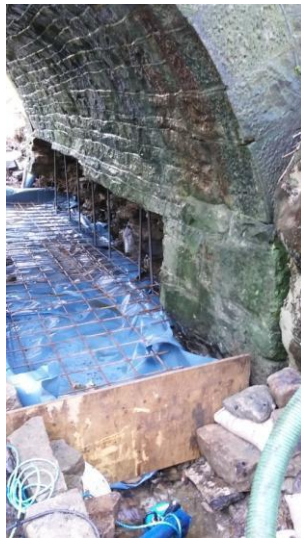
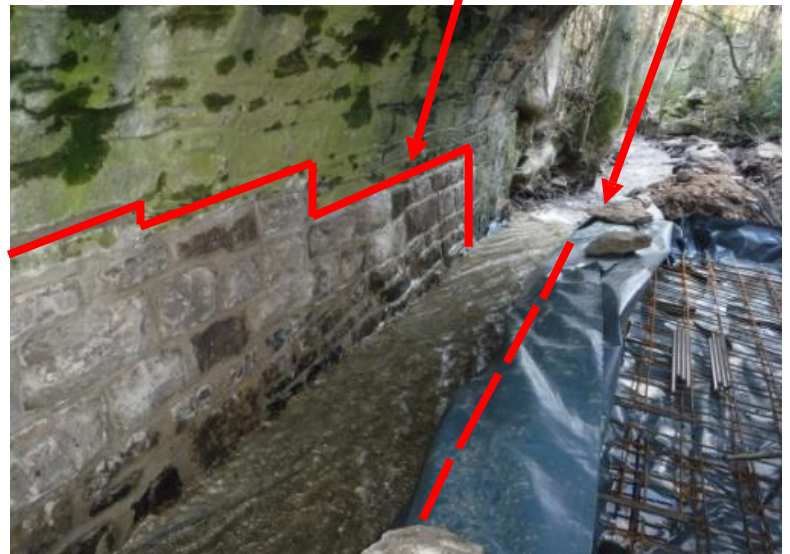
**During:**

The road was closed, and the construction works took place over two weeks in January 2016. The team created a dam so that the watercourse could flow and pumps were in attendance 24/7 in the event that flood water increased. A construction joint was created at midpoint to allow the flow to be switched when the first half of the invert was cast.
